# **EXPERIENCE AND BENEFIT OF USING EL-CID FOR TURBINE-GENERATORS**

Electric Power Research Institute  
Motor & Generator Predictive Maintenance & Refurbishment Conference  
Orlando, Florida  
November 28-30, 1995

G. Klempner  
Ontario Hydro

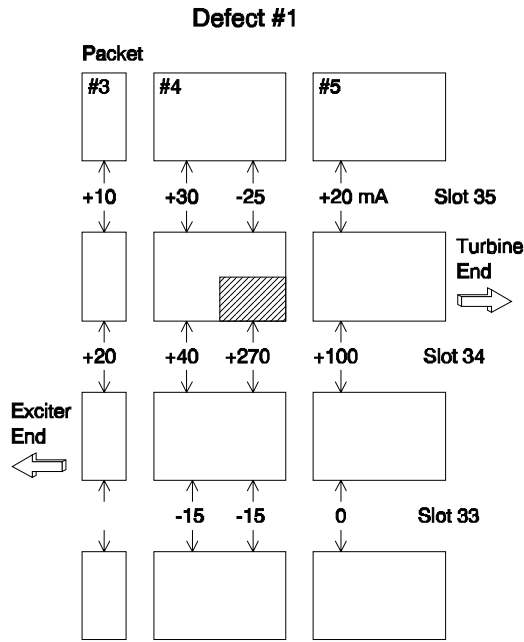
Figure 7

The first indication was located on the 3rd core packet in from the exciter end of the generator, on the tooth between slots 34 and 35. Since the reading across slot 34 was high at +270 mA, and

the reading across slot 35 was near normal, it was estimated that the fault was at or near the top of the tooth, on the side nearest slot 34. See Figure 7.

The faults were estimated to be near the top of the tooth by local scanning with El-CID flex head probes and over a substantial portion of the tooth top. In addition, the same measurements above were made in the “Phase” mode of the El-CID signal processing unit and showed levels no higher than the M.P.D. due to excitation. Therefore, it was estimated that the damage found was likely due to insulation deterioration rather than solid interlaminar iron damage. As stated previously, iron damage has been found to produce “Phase” readings over the fault area, several times the M.P.D. level.

Repair of both faults were carried out by localized grinding down of the tooth tops of both core packets by approximately 1/4". The tooth tops were then electro-etched with a 20% phosphoric acid solution to ensure separation of the laminations and that insulation could be detected to remain between all adjacent laminations on the tooth.

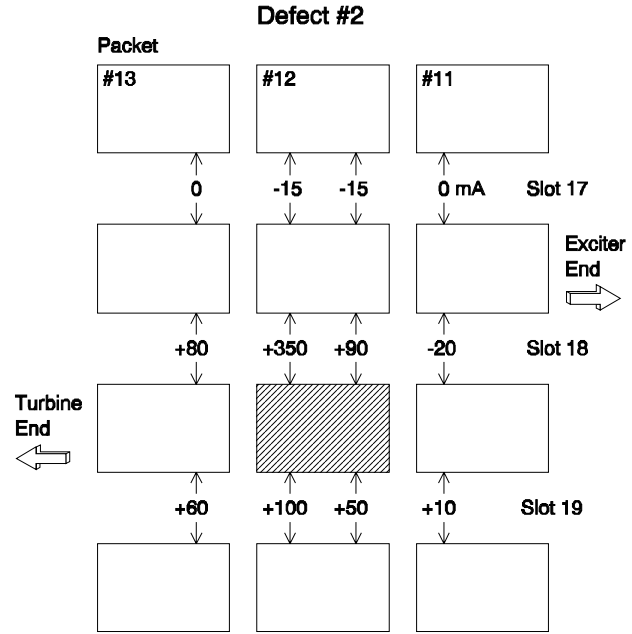
Figure 8

The second indication was located on the 12th core packet in from the exciter end of the generator, on the tooth between slots 18 and 19. The reading across slot 18 was high at +350 mA. The reading across slot 19 was also high at +100 mA but was near normal across slot 17. Therefore, it was estimated that the fault was at or near the top of the tooth between slots 18 and 19, but more on the slot 18 side of the tooth. See Figure 8.

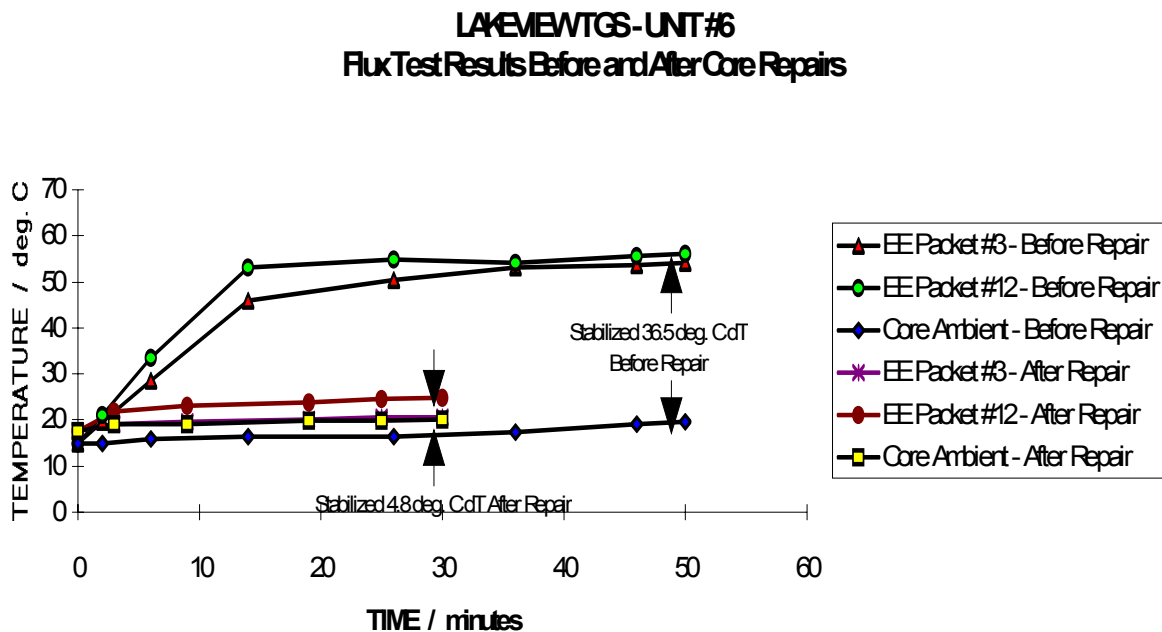
Figure 9

The first defect on the 3rd core tooth packet between slots 34 and 35 produced a temperature rise of 33.8°C above core ambient at 15 minutes into the test. The fault temperature then stabilized to a constant temperature rise of 34.5°C above core ambient for the remainder of the test. The fact that the hot spot showed up immediately and produced a rapid rise time and stabilization, supported the EI-CID conclusion that the fault was near the iron surface. See Figure 9.

The second defect on the 12th core tooth packet between slots 18 and 19 produced a stabilized temperature rise of 36.5°C above core ambient also by approximately 15 minutes into the test. The fault temperature remained fairly stabilized at this level above core ambient for the remainder of the test. Again, the fact that the hot spot showed up immediately and produced a rapid rise time and stabilization, supported the EI-CID conclusion that the fault was near the iron surface. See Figure 9.

To further confirm the repairs and verify the EI-CID results, a second Flux test (also at identical excitation levels) was performed. The Flux test showed temperature rises on both fault locations of now only 4.8°C after 30 minutes. See Figure 9. Therefore, Ontario Hydro's criteria of no hot spots above 5°C was met and the damage to the stator iron was considered repaired.

Finishing of the defect repair was completed by an application of a suitable penetrating/insulating epoxy.

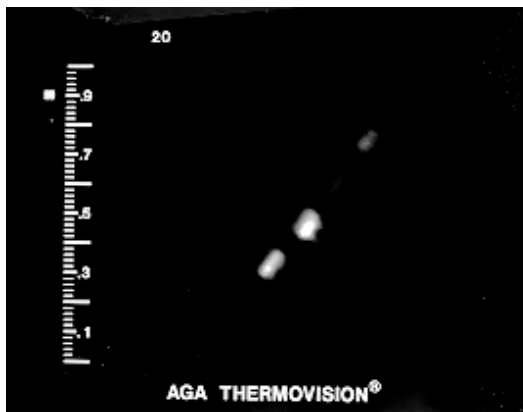
After a winding failure on this stator in August 1989 and an inspection of the stator iron, it was noticed that there were a number of 1st packets on the exciter end of the stator, around the bore circumference, that had visible damage. The core iron was found to be loose on a number of these 1st packets at the core end, and the insulation obviously worn away on some. An EI-CID test confirmed the damage in the areas indicated, but that the rest of the core was found defect free.

To determine the severity of the damage, a Flux test was also done to compare results. In fact, the Flux test results verified the location of the faults and that the remainder of the core was indeed free of damage. Figure 10 shows a thermographic close-up view, in the rotating mirror, of some of the worst defects. Figure 11 is an isotherm view of a number of defects, viewed both directly on the core end and of their image in the mirror.

The core damage was then repaired by inserting thin pieces of mica between the loose laminations, soaking the area with a penetrating/insulating epoxy and then re-tightening by driving a 1/16" G10 glass stemming piece radially into the center of the 1st core packet. See Figure 13. The result was the re-establishment of insulation between core laminations and tightening of the core end iron to reduce the possibility of further fretting in service.

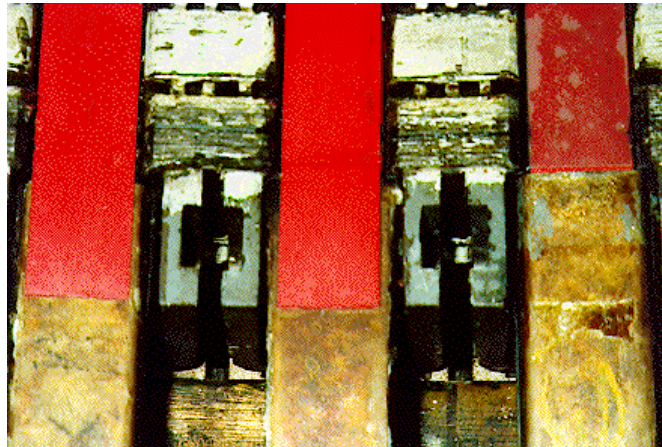
Figure 13

The repairs made were extensive and were the best that could be done without very expensive restacking of the stator core. The core tightness on the teeth was re-established as best as possible but was and is still regarded as a local repair and is not considered a substitute for re-pressing of the core.

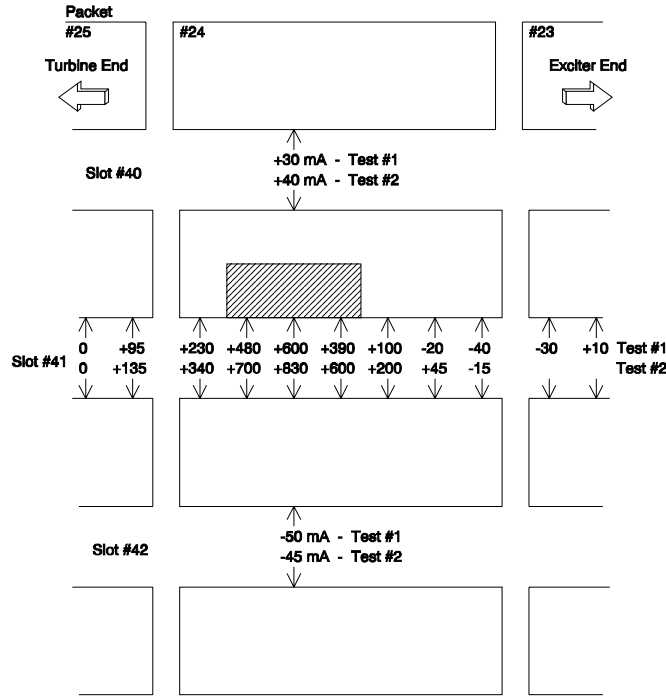
The defect signal was found to be across slot 41 on the 24th core packet in from the exciter end of the generator. A complete EI-CID signal profile of the fault area was made and is shown in Figure 14. The significant points to notice on the fault map are the low readings across slots 40 and 42 which tend to indicate that the fault is deeper down in the slot. In addition, the signal across slot 40 is the same polarity as the main defect signal while the signal across slot 42 is the opposite polarity. This suggests that the defect is most likely on the side of the tooth in slot 41, but on the tooth adjacent to slot 40.

However, the defect location across slot 41, on packet 24 in from the exciter end of the machine, now recorded an increased EI-CID signal level to +830 mA in the exact location of the original that was found to be +600 mA. All other adjacent readings increased as well. See Figure 14 above.

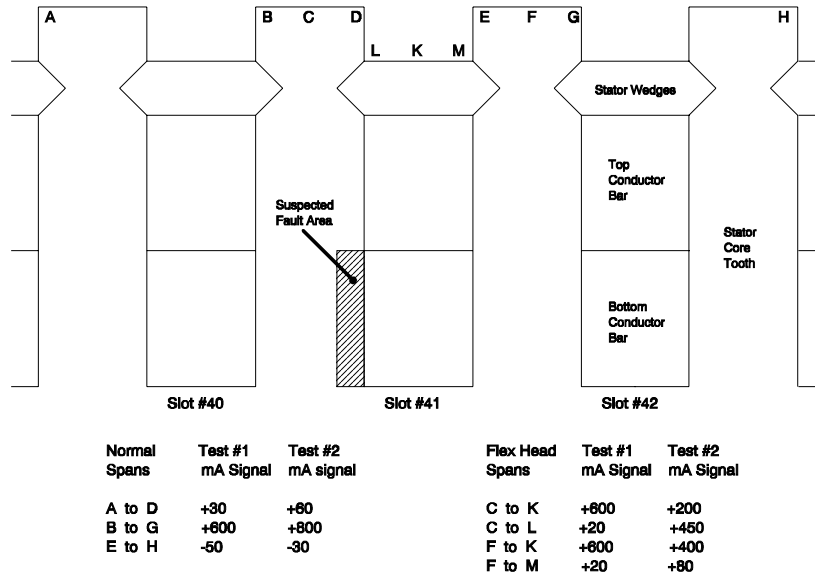
Additional readings were taken with a smaller EI-CID flex head probe to try to determine the depth of the fault. Figure 15 is a map of the readings taken and the results. The significance of these results are that the readings also tend to indicate that the fault is not near the top of the stator tooth but rather farther down the slot. It is our speculation that the fault is most likely near the bottom of the slot next to the bottom conductor bar.

Additional readings were again taken with a smaller El-CID flex head probe to fully characterize the fault. Figure 15 above also shows the results of this second test. The signals recorded were now higher in the more localized shorter measurement spans. The significance of this is uncertain but it was thought at the time that the insulation now may be becoming heat affected, causing the interlaminar insulation near the fault to be deteriorated over a larger surface area. Speculation was still high that the main fault is near the bottom of the slot next to the bottom conductor bar.

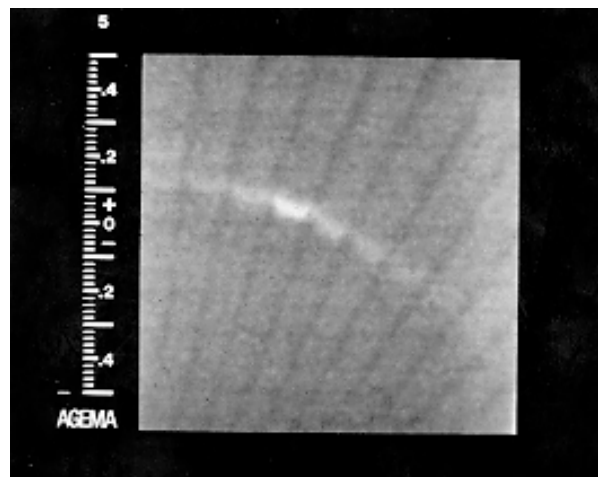
Figure 16

Since the generator was fairly new, there was considerable concern that the EI-CID test may not be correct. Therefore, a 75% rated Flux test was done and the core scanned for hot spots with an Agema infra-red system. The defect location was confirmed and is shown in a thermographic view in Figure 16.

The Flux test produced a very slowly rising ambient core temperature and a very slow rising fault temperature that only reached 5°C above the rest of the core after one hour. The test was run for an additional 2 hours and the temperature rise only reached 8°C above the rest of the core. This type of information tends to confirm that the defect is likely deeper in the slot, relatively small, highly localized, and probably in the infant stages. Therefore, the unit was returned to service with the intent to inspect again in about three years.
